**Advanced Multicomponent  
Seismic Software**

**Analysis of seismic data recorded in August 2026  
by network C8 (stations SV1S-SV5S)  
at Aquistore test site**

Report AQ-2026-07-IM

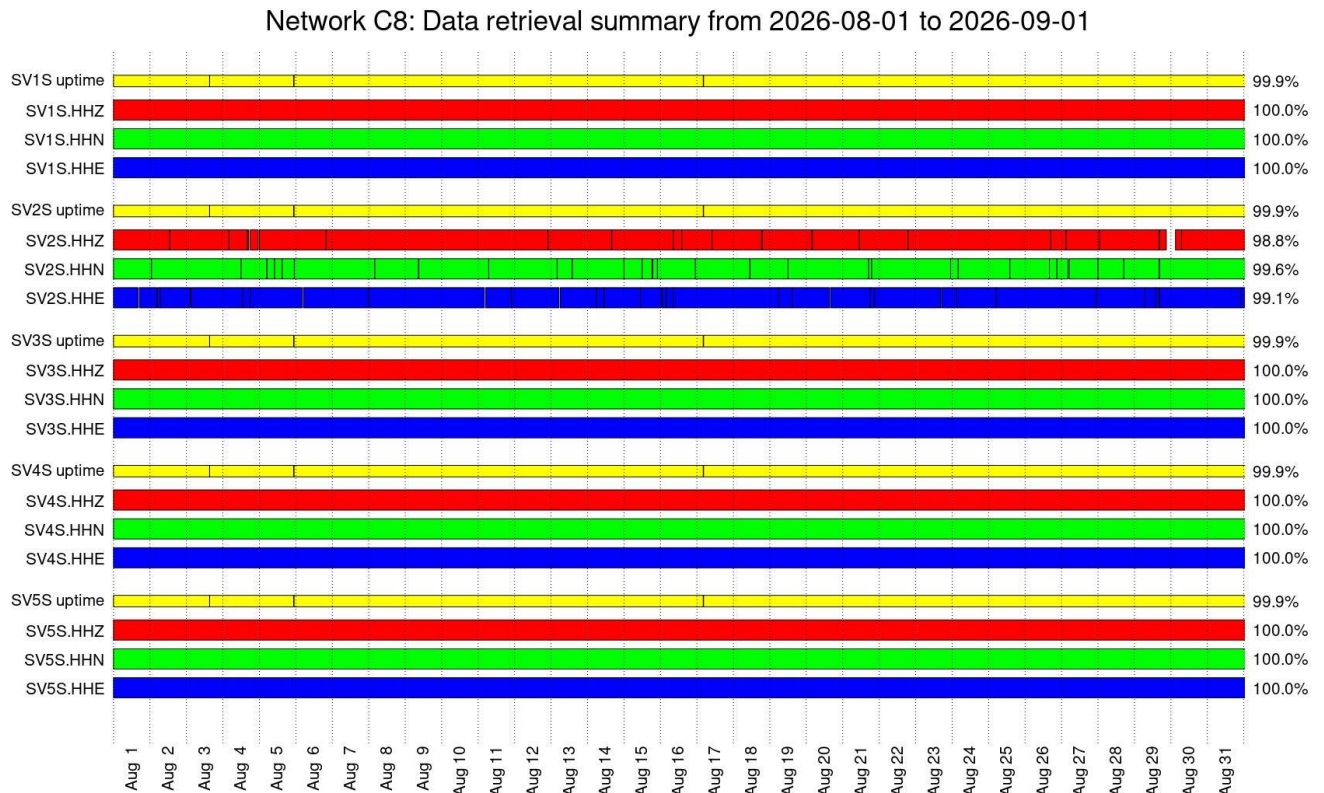
Station performance for August 2026 is summarized in Figure 1, and their state-of-health parameters are shown in Figure 2. Power-supply voltages looked generally good and station operation was practically uninterrupted.

Figure 1. Retrieved data intervals for all channels (red, green, and blue bars) and uptimes (yellow). Total percentages of measured uptime and data retrieval are shown on the right.

Data recovery from all stations was near 100% (Figures 1 and 2).

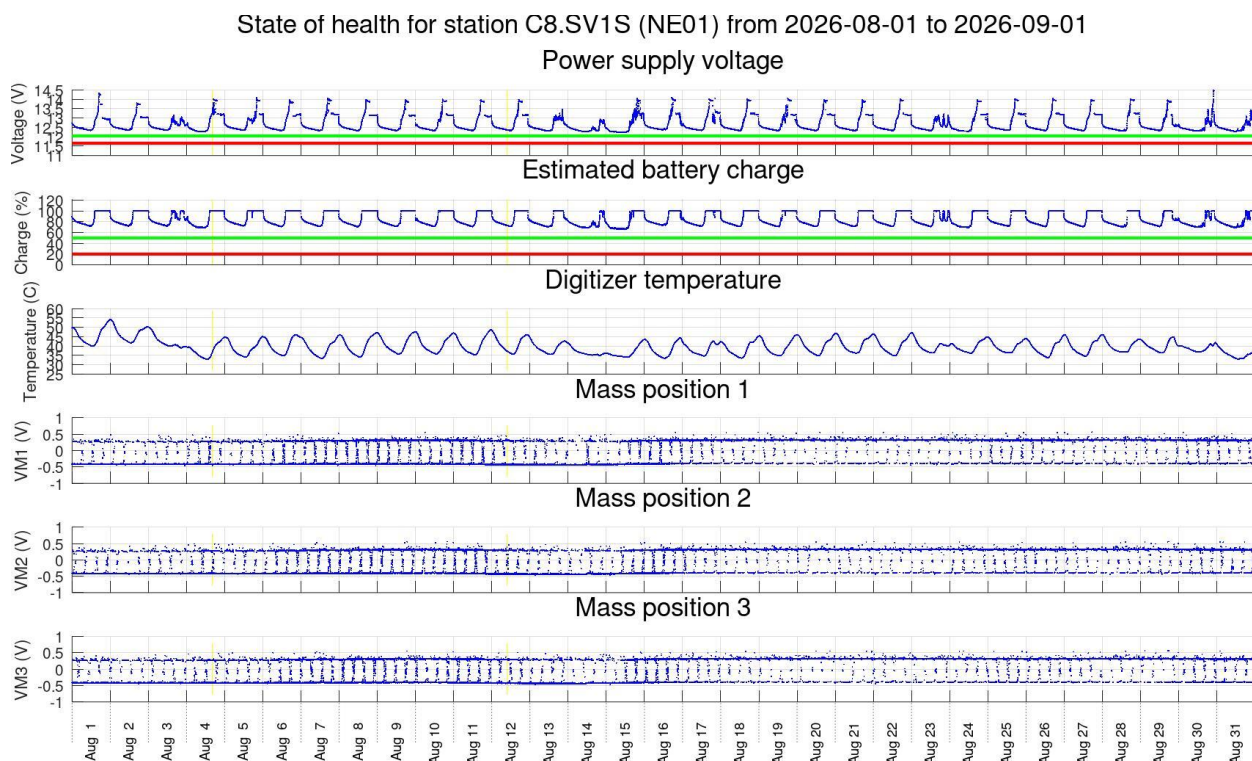
In Figure 2, note the erratic behaviours of sensor “mass position” for station SV1S. This behaviour is likely related to numerous spikes present in this station’s data (next sections of this report). These observations suggest that the sensor cable connector have become faulty.

Figure 2. State of health parameters for each station (SV1S here). Image headings: power supply voltage, estimated battery charge levels, temperature on board, voltages measuring mass positions.

- Seismic data retrieval from all stations was nearly 100%.
- Records from station SV1S are strongly contaminated with persistent spikes. To correct this problem, replacement of the sensor cable is recommended.
- Intermittently, records from stations SV3S and SV4S also contain significant intervals of spikes.

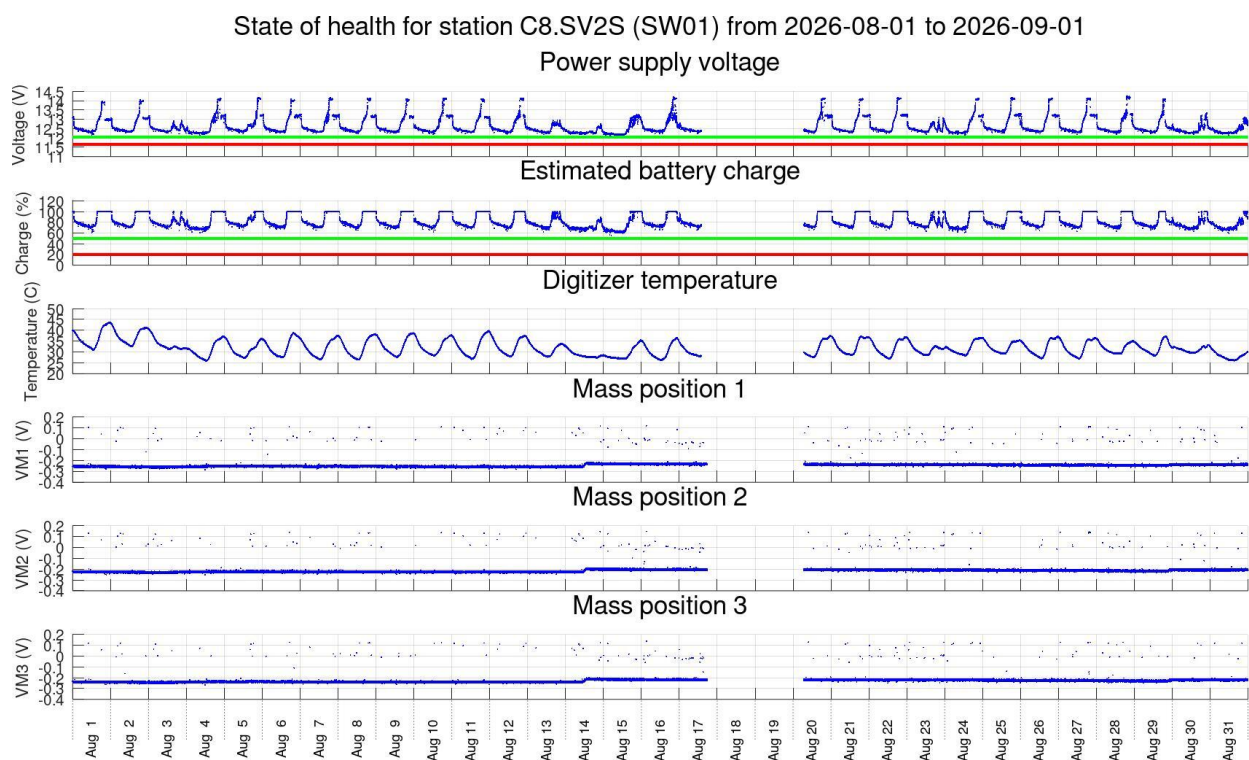
Figure 2, continued, station SV2S. SOH data between August 17 and 20 were missed in manual downloading.

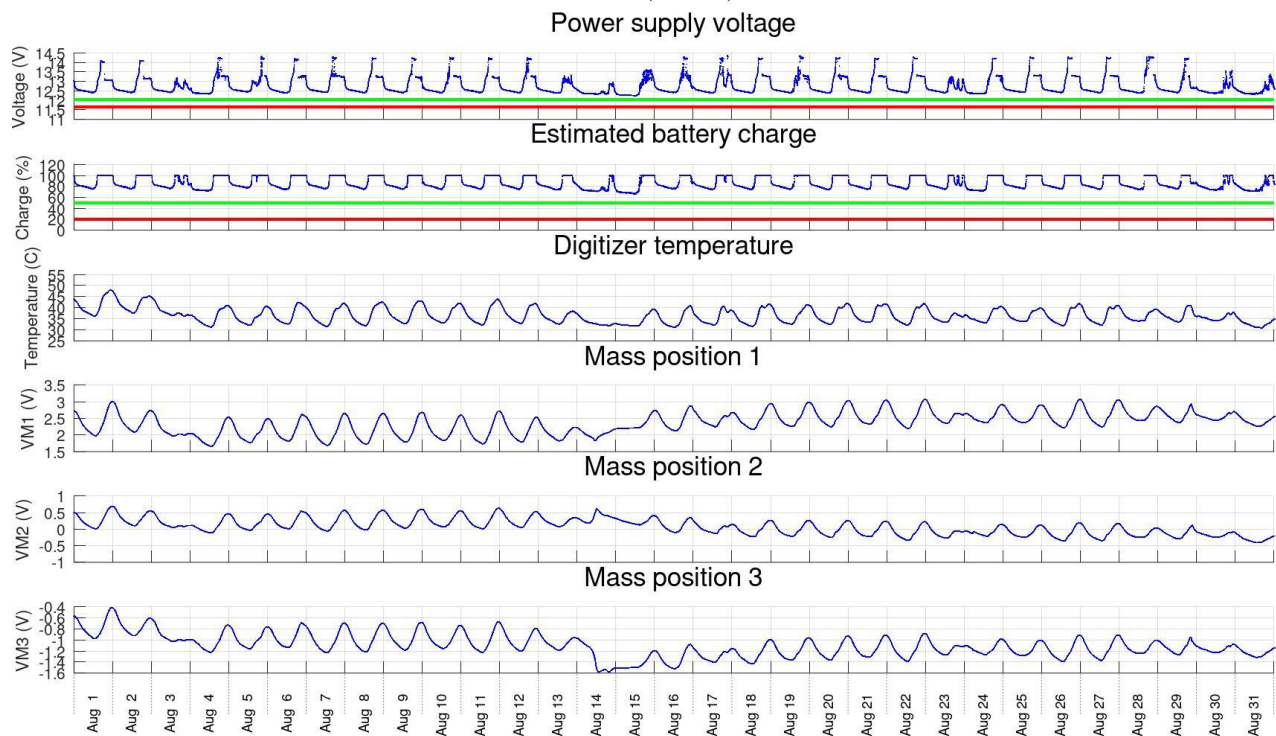
Figure 2, continued, station SV3S.

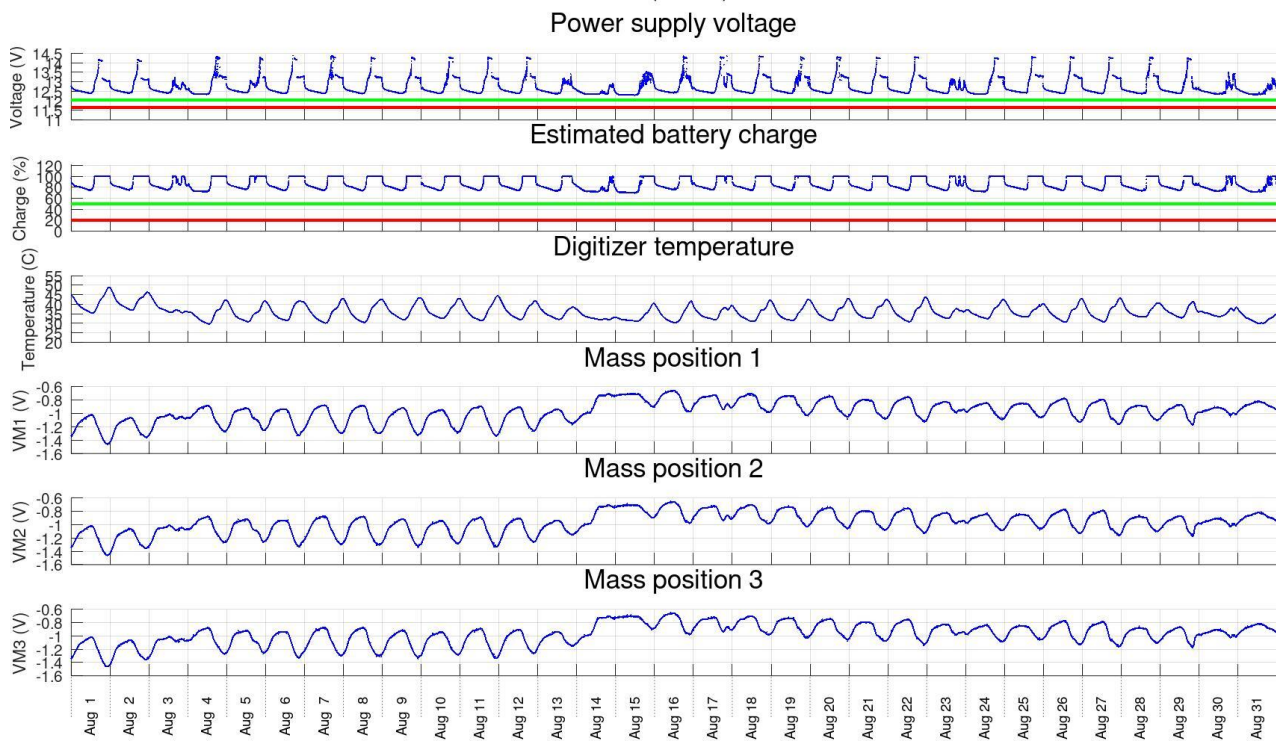
Figure 2, continued, station SV4S.

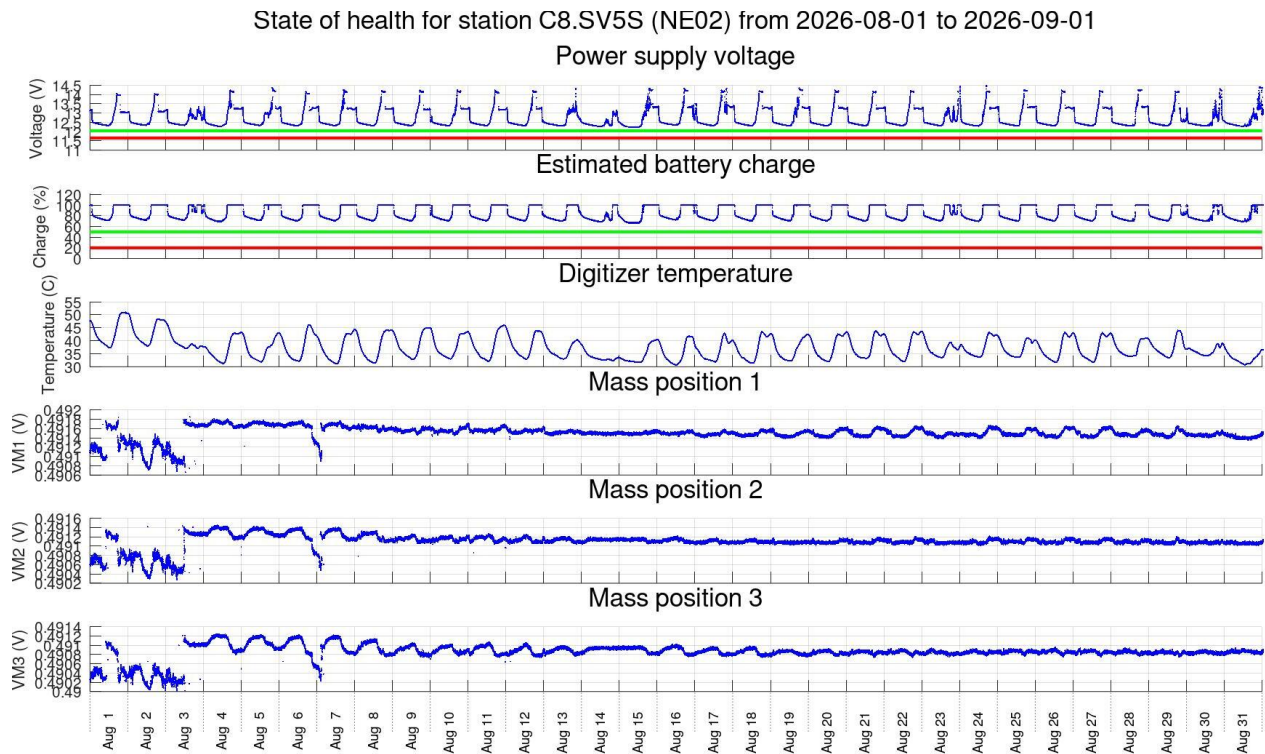
Figure 2, continued, station SV5S.

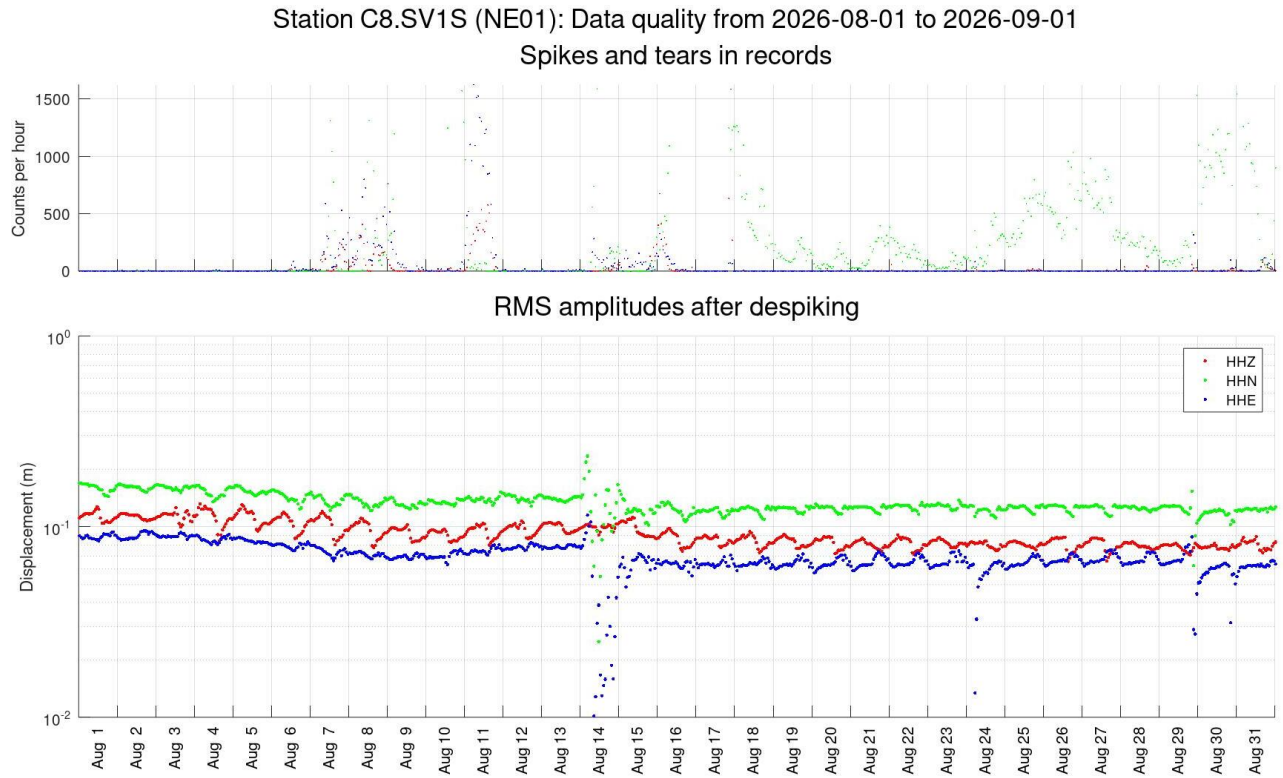
Records from station SV1S continued to be strongly contaminated with spikes noted in the preceding report. Also as in preceding reports, stations SV3S and SV4S also show occasional intervals of spikes in the records.

Figure 3. Measures of data quality in hour-long intervals. Station names and time intervals are indicated in plot headings (SV1S in this plot). Red, green, and blue colours correspond to channels HHZ, HHN, and HHE, respectively (as in Figure 1).

**Top panels:** Numbers of spikes and tears per hour auto-detected in data records.

**Bottom panels:** RMS ground displacements (meters).

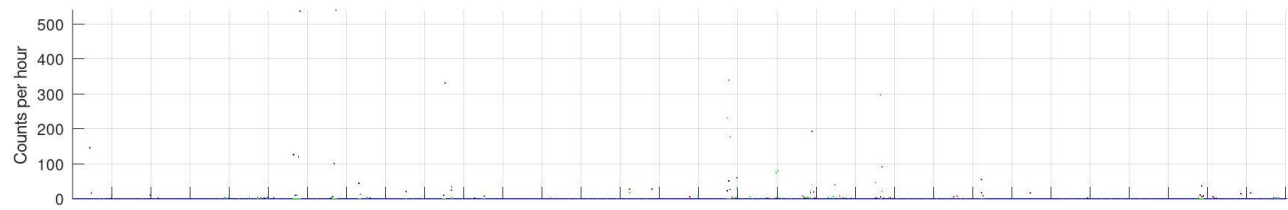
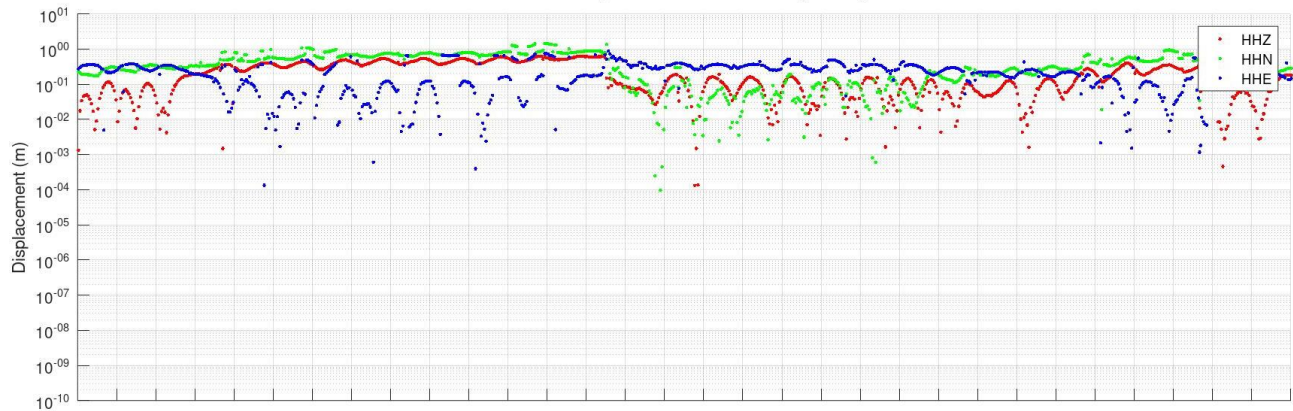
Station C8.SV2S (SW01): Data quality from 2026-08-01 to 2026-09-01  
Spikes and tears in records

Figure 3 shows two measures of data quality evaluated for each channel:

- 1) Numbers of spikes and tears (sharp changes of DC level) within 1-hour time intervals;
- 2) 1-hour interval root-mean square (RMS) average amplitudes in each channel.

Figure 3, continued. Station SV2S.

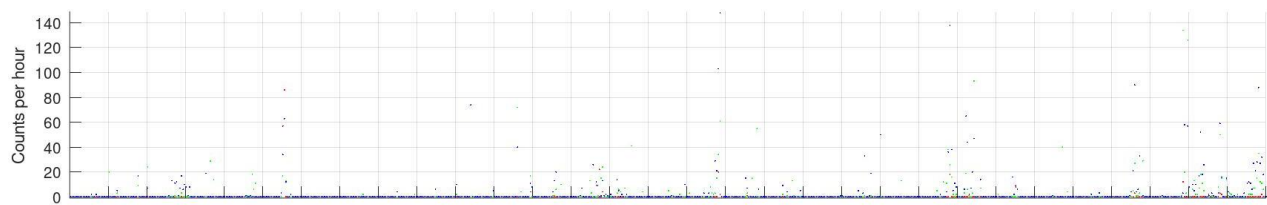
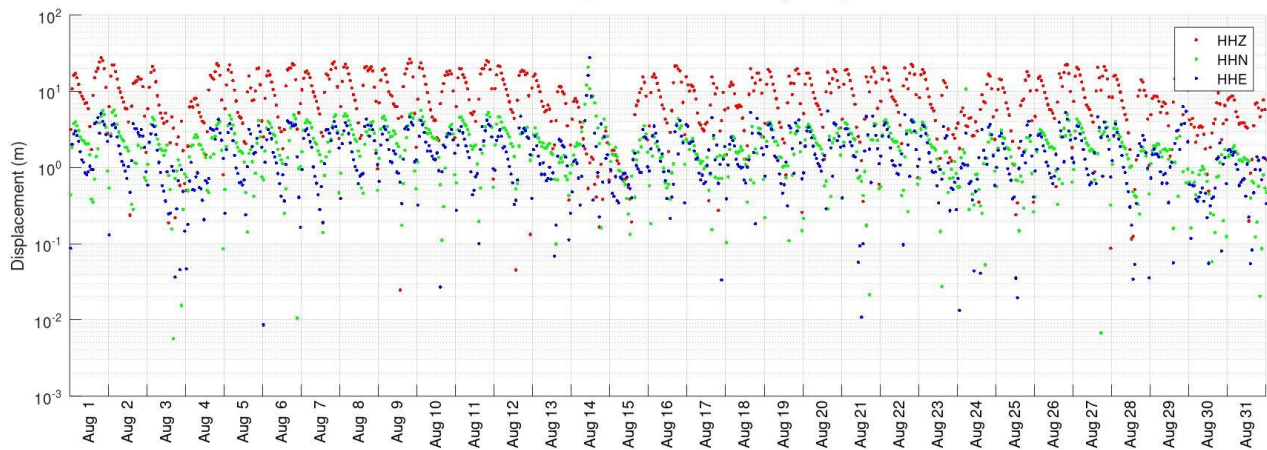
Station C8.SV3S (NW01): Data quality from 2026-08-01 to 2026-09-01  
Spikes and tears in records

Figure 3, continued. Station SV3S. Note the large numbers of spikes, also seen in some waveform records below in this report.

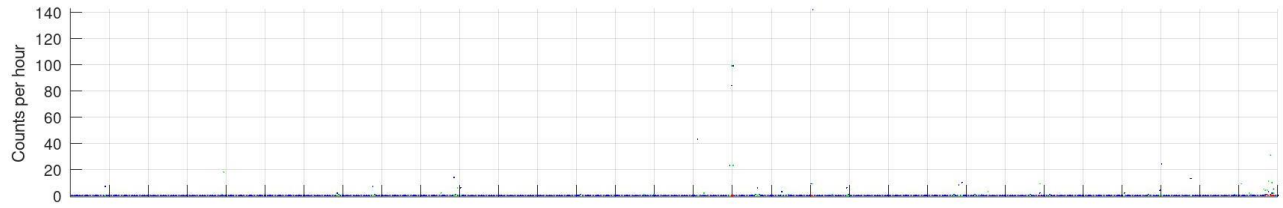
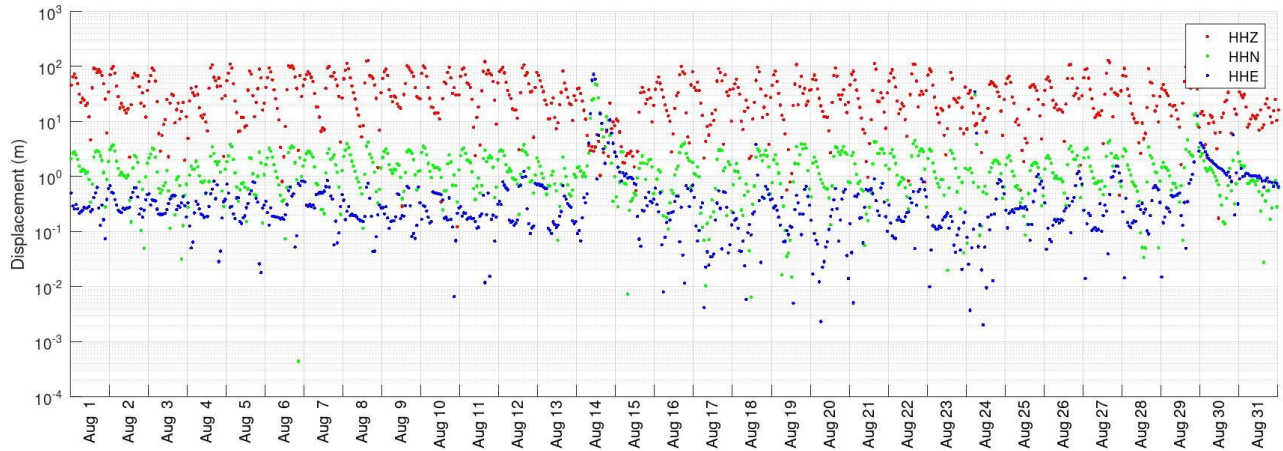
Station C8.SV4S (SE01): Data quality from 2026-08-01 to 2026-09-01

Figure 3, continued. Station SV4S. Also note significant numbers of intermittent spikes.

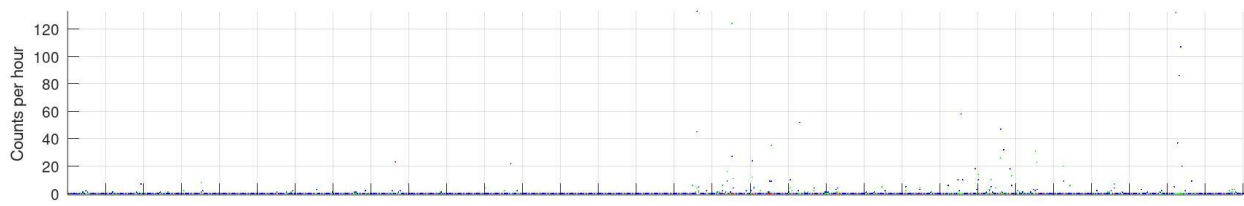
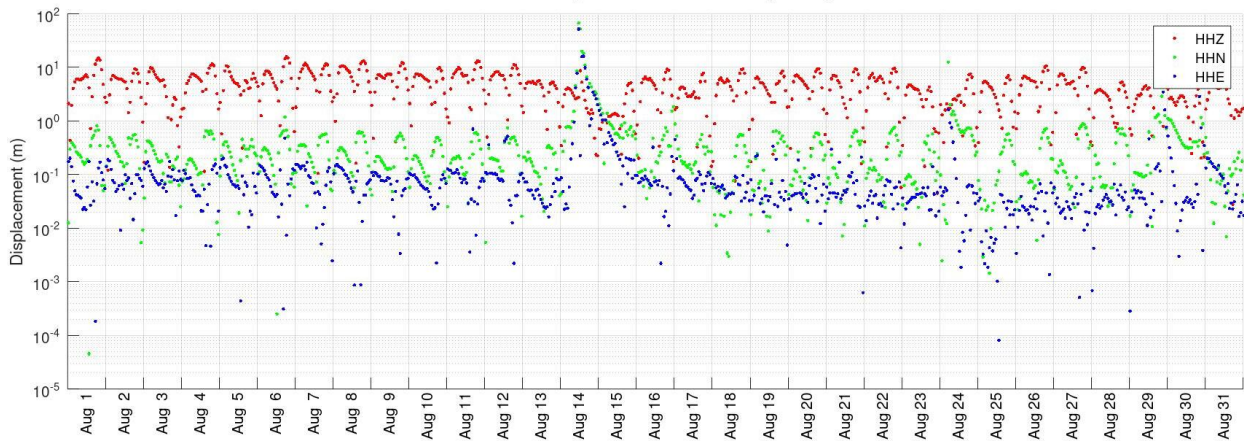
Station C8.SV5S (NE02): Data quality from 2026-08-01 to 2026-09-01

Figure 3, continued. Station SV5S.

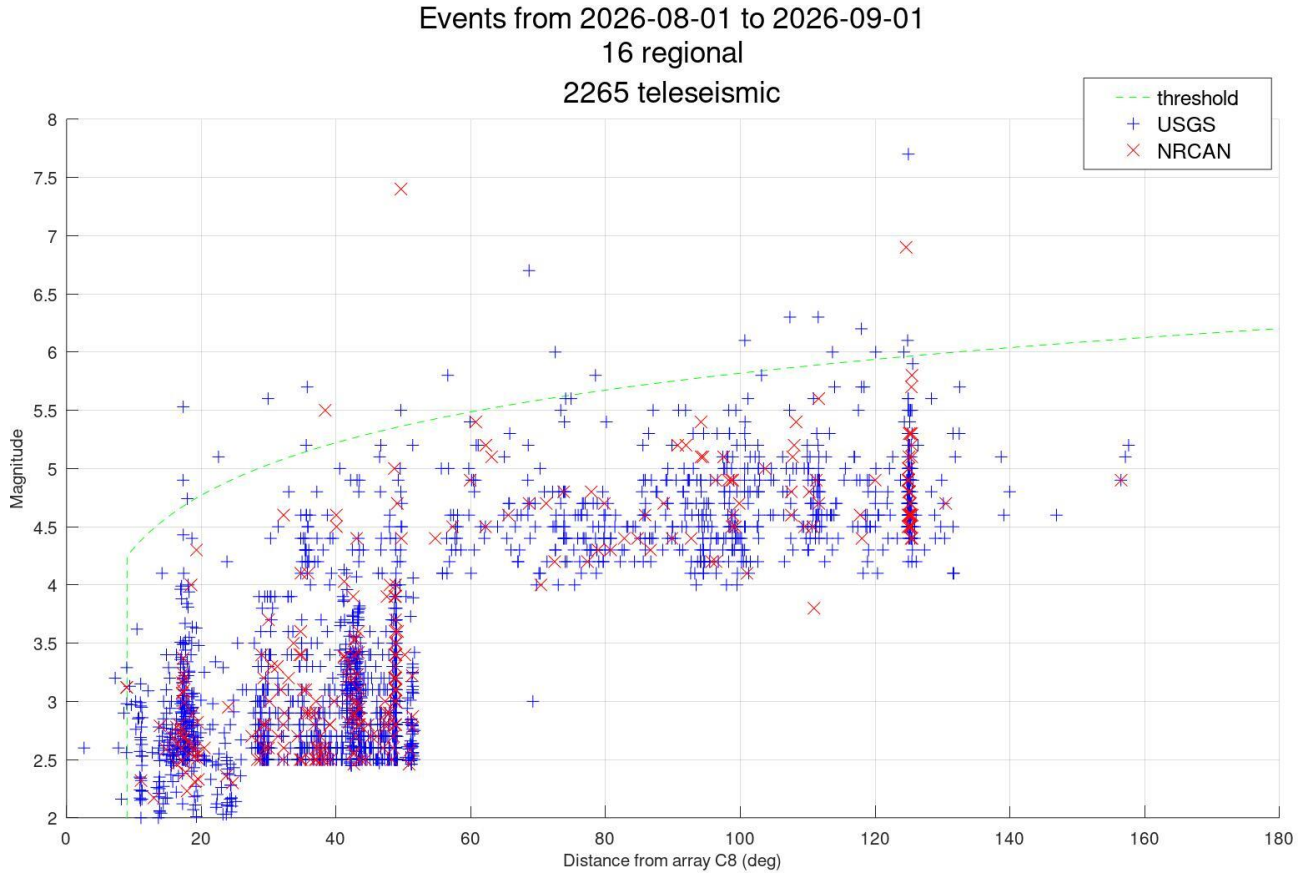
Earthquake data bulletins for the period of this report were obtained from NEIC (USGS) and NRCAN web services (Figure ). Events larger than magnitude 2.5 were taken from USGS, and all available events were retrieved from NRCAN. Events located at regional distances or with magnitudes above the selected  $magnitude \propto distance^{1.5}$  threshold (dashed green line in Figure ) were reviewed interactively (next section).

Figure 5. Magnitudes and distances from Aquistore for earthquake parameters downloaded from USGS and NRCAN databases (legend). Dashed green line shows the detection threshold above which a manual review of events was performed.

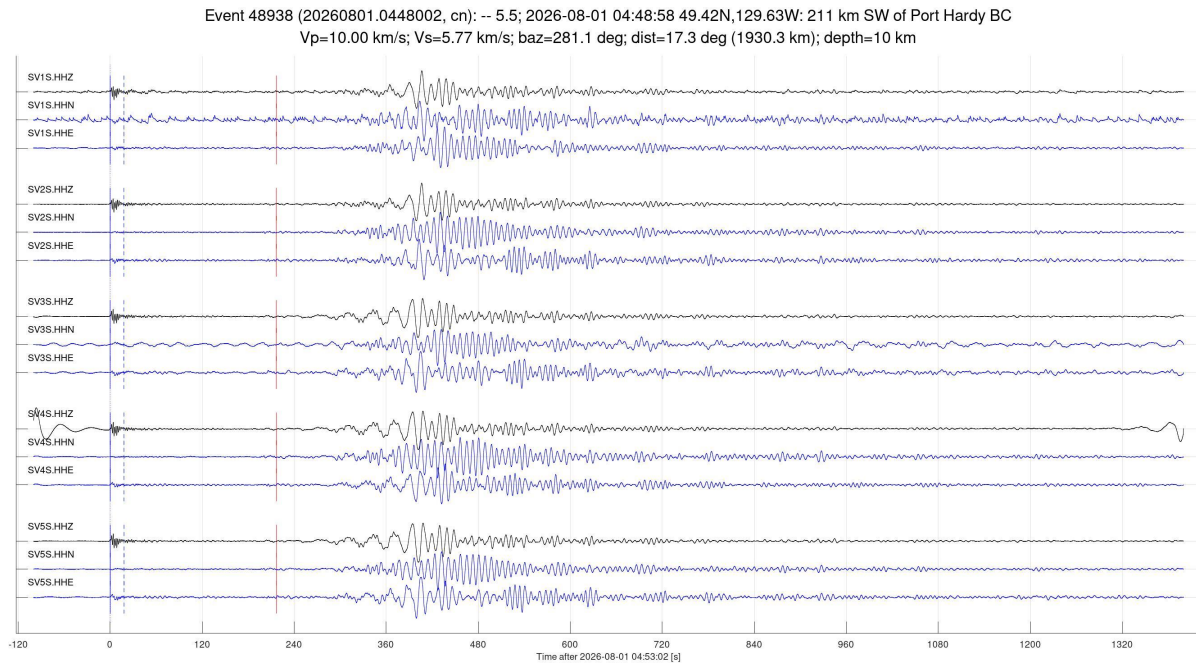
Above the threshold line in Figure 5, 20 teleseismic events (class 1 in Table 2) were identified in August 2026 (Figure 6). Most teleseismic events can be recognized by the onsets of S waves (red marks in Figure 6) and surface waves (low-frequency arrivals after the S waves). Some of the events also show strong P-wave (blue bars near time zero in Figure 6), and several events show strong and P/S or S/P mode conversions (between the P-wave and S-wave times).

In for most events in Figure 6, note that records from station SV1S are extremely noisy, particularly channels HHZ and HHN. The noise is caused by spikes occurring randomly but synchronously in both channels. This suggests that the noise may be due to malfunctioning sensor cable or connector.

Figure 6. Teleseismic events detected at Aquistore in August 2026. Plot headings show catalogue IDs, magnitudes, times, distances in degrees, source coordinates and localities, back-azimuths ('baz='), distances ('dist=') and source depths. Vertical-component records are shown in black, and horizontal components in blue. Time zeros are located at the times of P-wave arrivals at the Aquistore array predicted in the reference model IASP91 and corrected interactively. Blue and red bars indicate the P-wave and S-wave picks, respectively. Ignore the (technical) cyan and dashed bars.

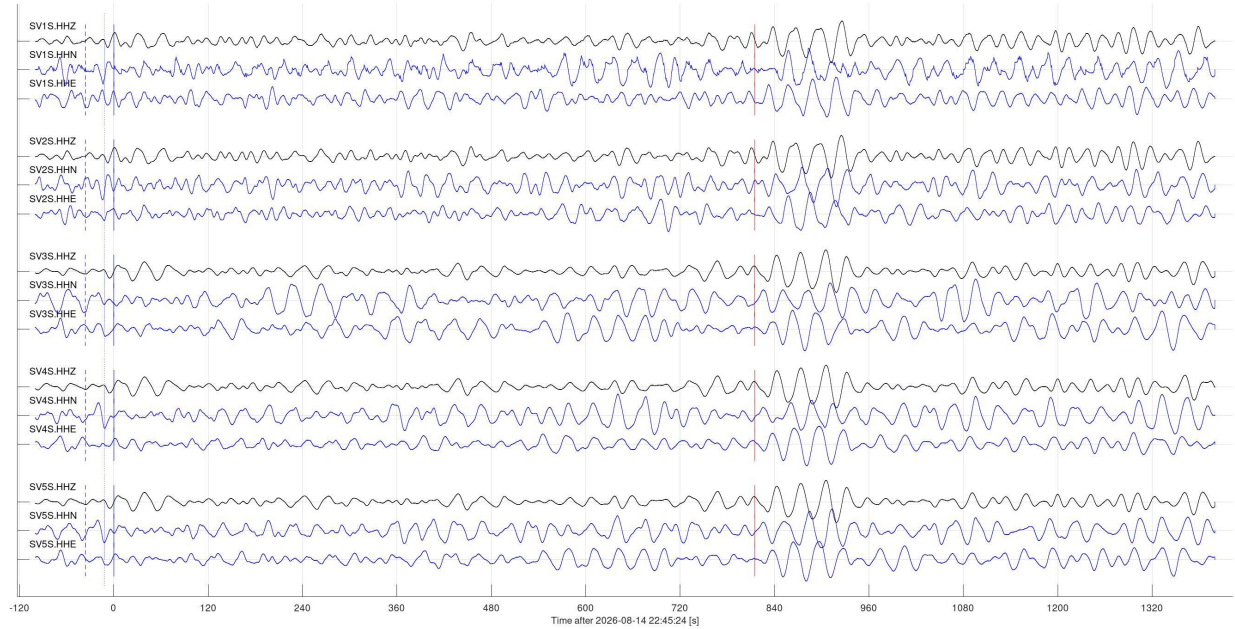
Figure 6, continued. Note that for such low-frequency events, S-wave and surface wave records are difficult to differentiate from local seismic noise near the site.

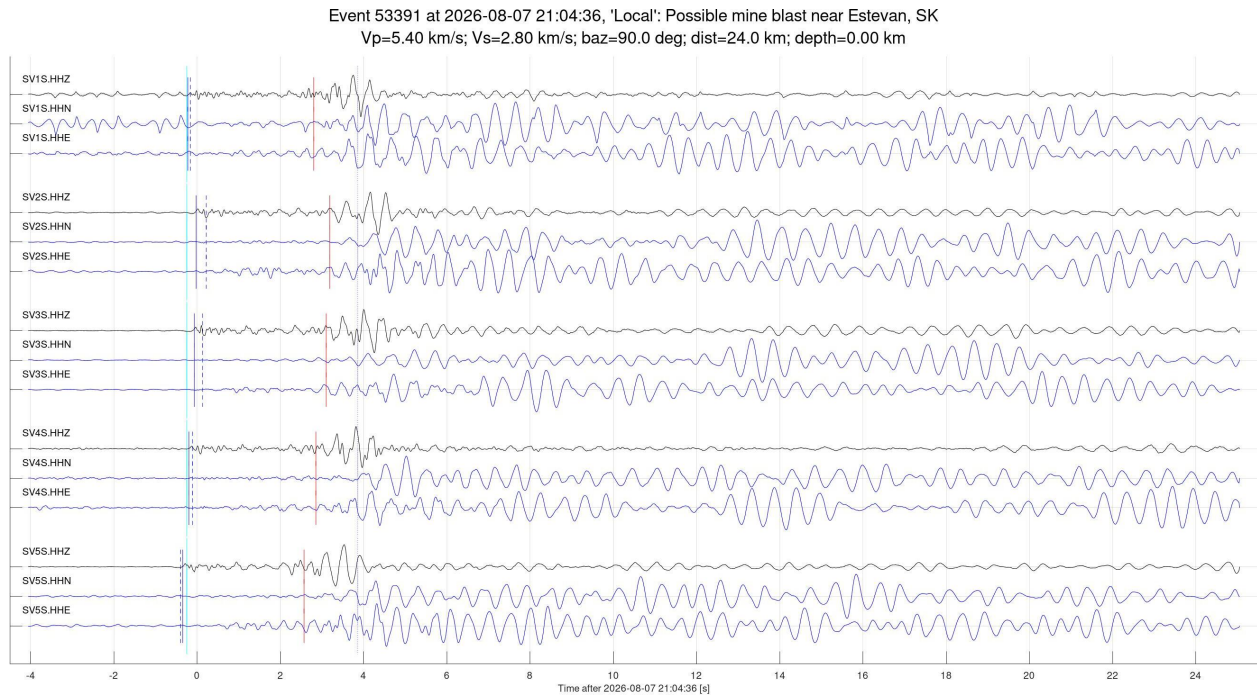
Five events were identified as mine blasts in the area of Estevan coal mining (Figure 8). Similar to recent reports, these blasts appear to be located at distances around 25 km from the Aquistore array. Accurate location was not attempted.

In Figure 8, note the significantly noisier records from station SV1S. These plots show that the spike noise level is below the strong signals from mine blasts. However, it is still prohibitive for detecting weaker teleseismic arrivals and likely the potential events occurring within the target zone.

Figure 8. Seismic arrivals produced by mine blasts at the Estevan mine. Colours and labels are as in Figure 6.

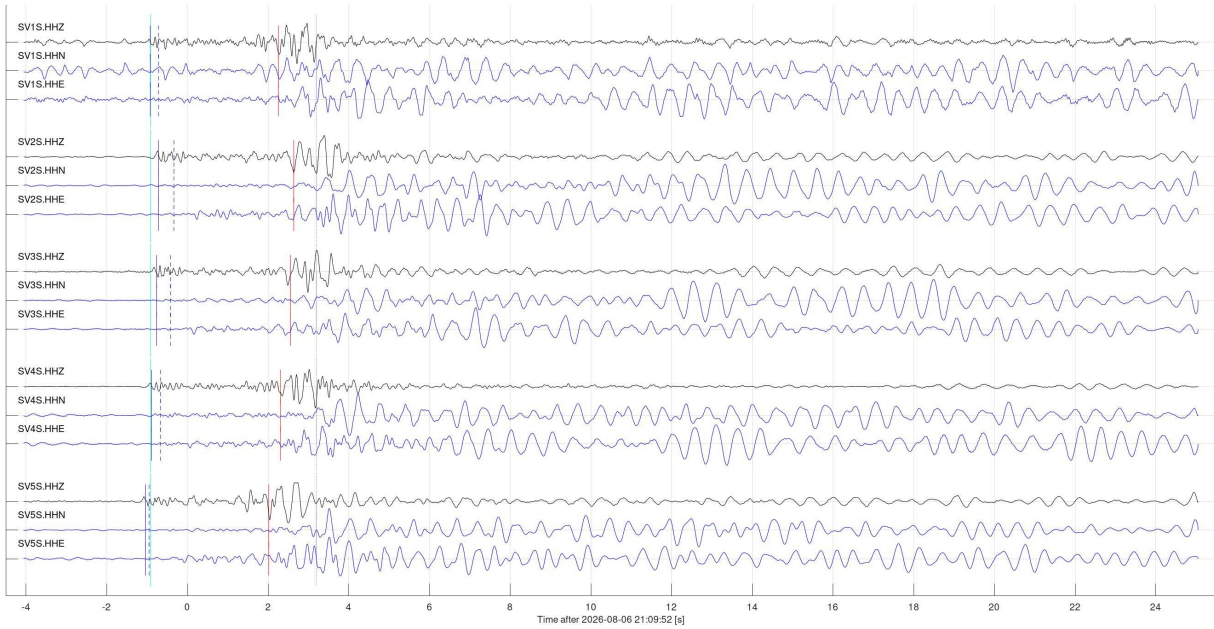
Numerous mining- and industrial-operations related seismic events were observed in the area. Many such events may be produced by trains or surface waves from teleseismic and regional events. Figure 9 illustrates two such events.

Figure 9. Sample events interpreted as due to mining activity in the area. Lines, colour bars and labels are as in the preceding figures.

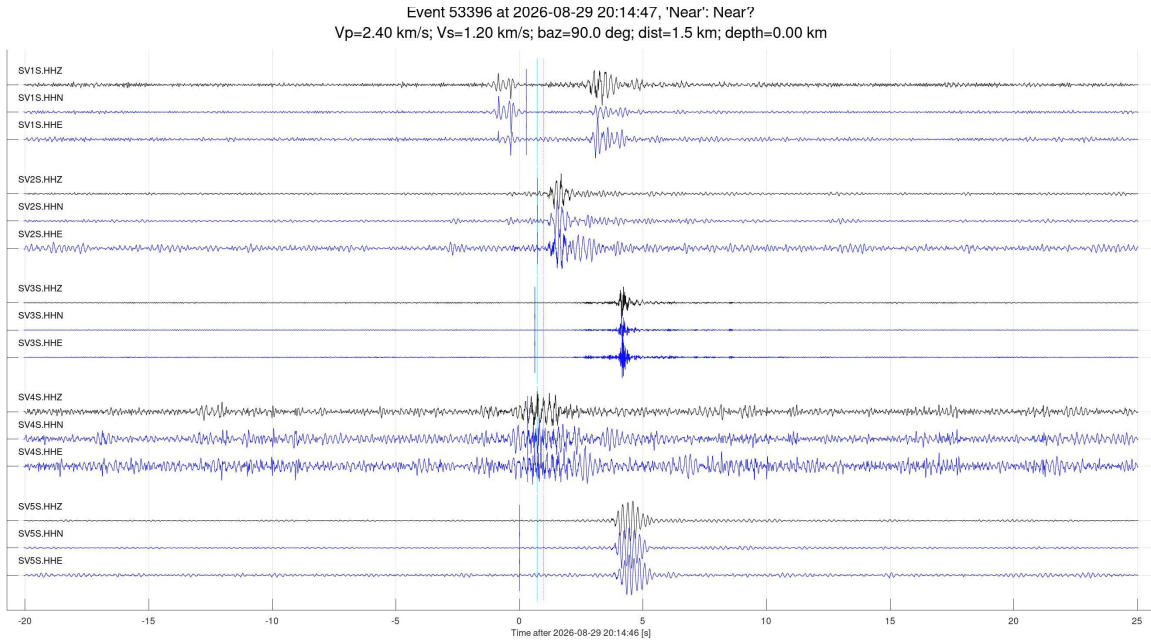
Three seismic events were identified as possibly occurring in the proximity of the array (class 4a) (Figure 10). The waveforms (strong and compact strikes) appear typical of heavy machinery. Large time moveouts between stations suggest S waves traveling in a very low near-surface velocity of about 0.2 – 0.3 km/s. Clearly, these events originated close to the surface. These events appeared in clusters of which only selected occurrences are shown in Figure 10.

Records shown in Figure 10 also indicate a complex near-surface attenuation structure of the site. The surface-wave signals are of significantly higher frequency at station SV3S although stations SV2S and SV4S are located closer to the source. This difference can be explained by much lower near-surface wave attenuation near station SV3S. However, an alternative explanation of this difference may be in the use of a surface sensor Trillium 120P instead of the posthole Trillium Compact installed at all other stations. It may be that surface installations work better in this environment. This question needs to be investigated on similar impulsive sources or controlled sources conducted in the area.

Figure 10. Possible event occurring near surface in the proximity of the array (class 4a in Table 2). Lines, colour bars and labels are as in the preceding figures. This event appears to be caused by heavy machinery operating near station SV3S.

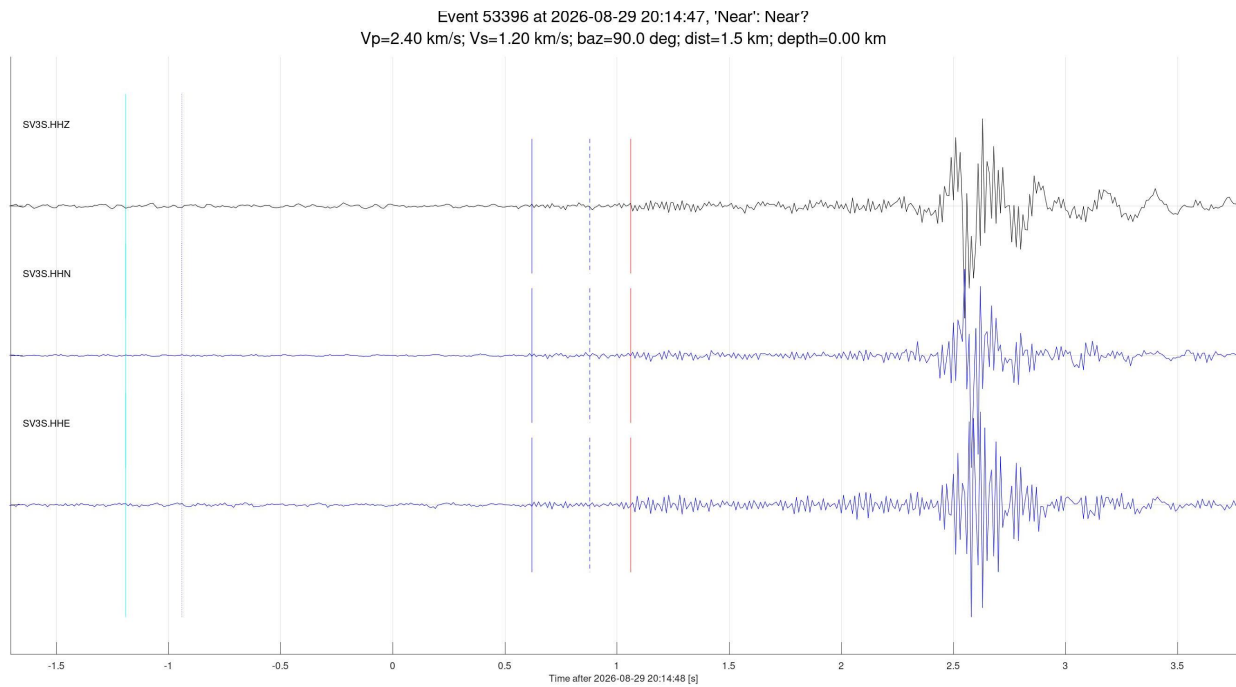
To illustrate one of these impulsive events more closely, Figure 11 shows a close-up view on event 53396 recorded at station SV3S. The waveforms look very similar to the seismograms produced by an impulsive surface source, such as mine blasts in Figure 8 but with much higher dominant frequency due to a closer location. From time separations between the P-, S-, and surface-wave arrivals, the source was likely located at 500-600 m south from station SV3S.

Figure 11. Detail of waveforms from event 53396 (Figure 10) at station SV3S. Note the P and S-wave arrivals (blue and red bars, respectively) and the strong surface wave following at about 1.5 s after the S wave.
